Avoiding Roundabout Design Failures - An Interactive Approach to Identifying Errors and Finding Solutions

Presented by
Nazir Lalani
Nazirlalani1@gmail.com

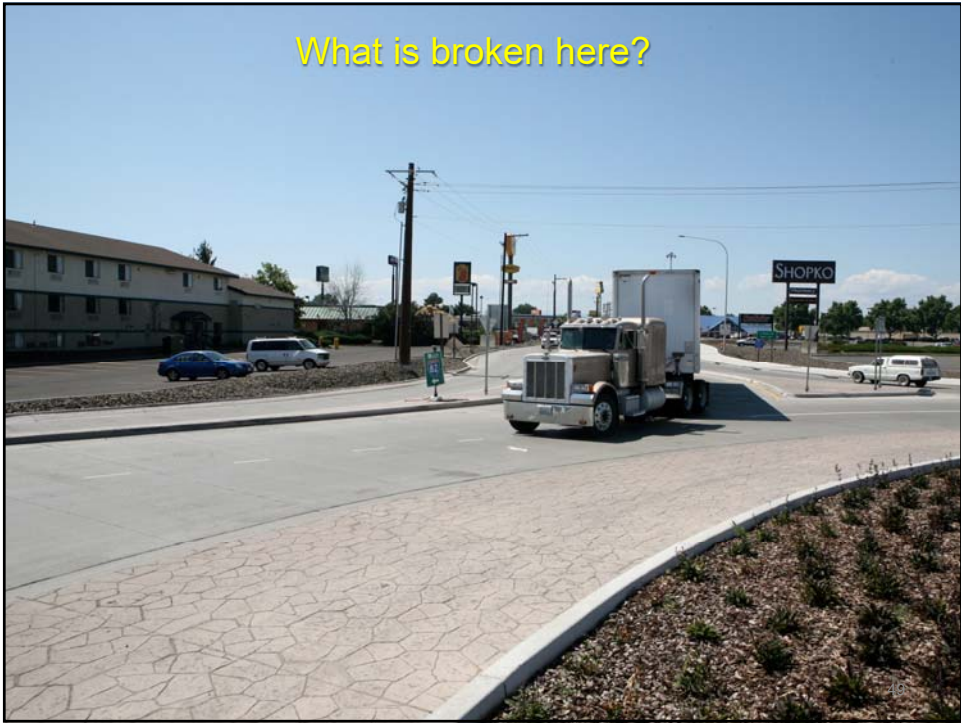
What is broken here?

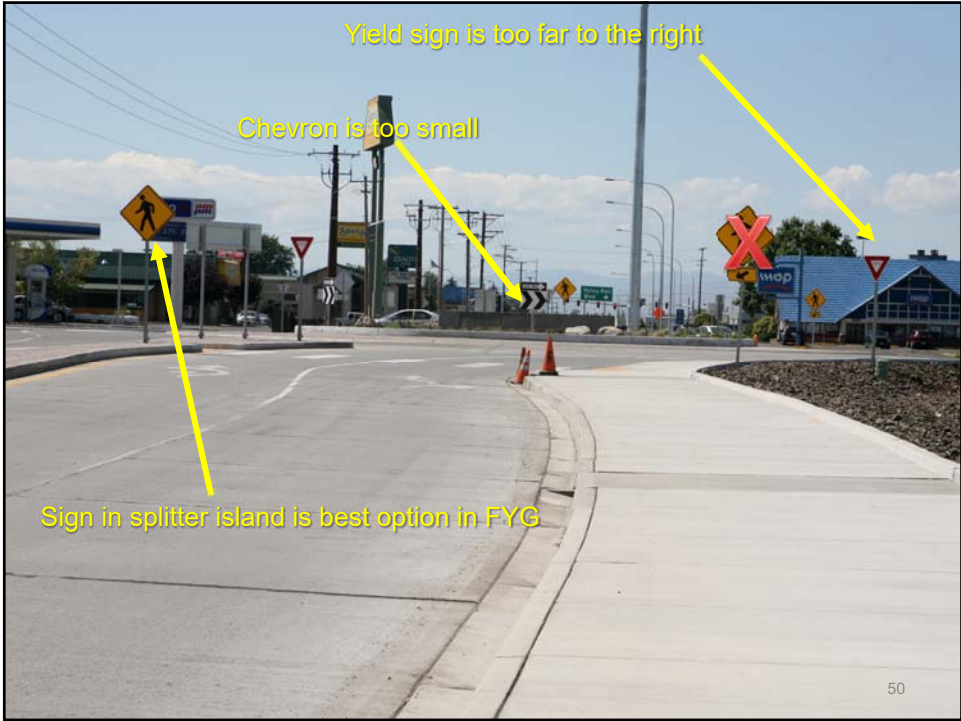
Yield sign is too far to the right

Chevron is too small

Sign in splitter island is best option in FYG

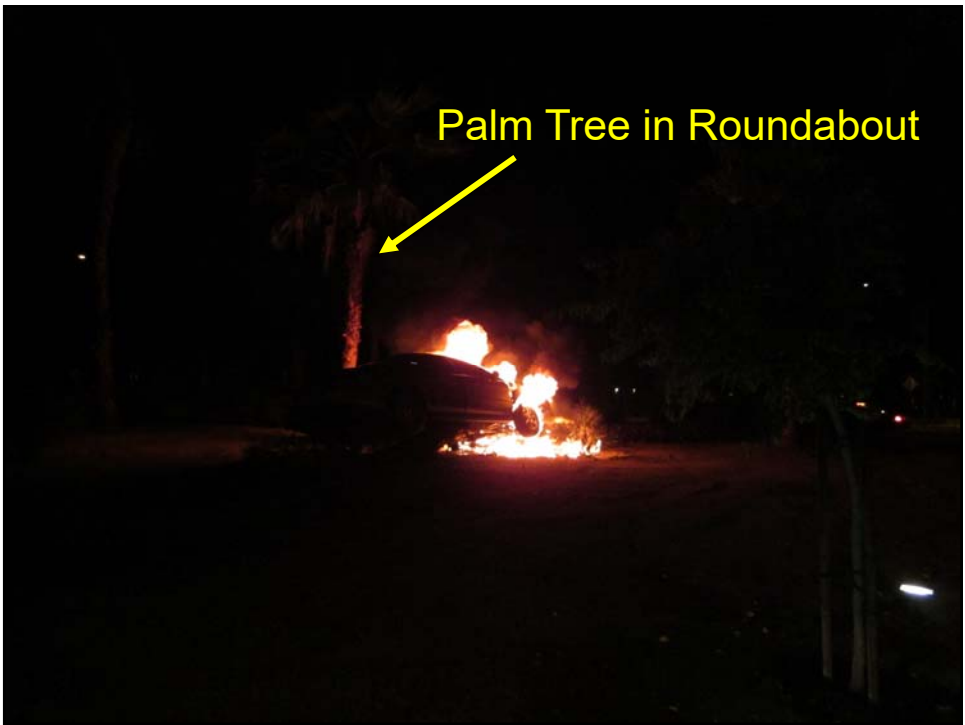
Palm Tree in Roundabout

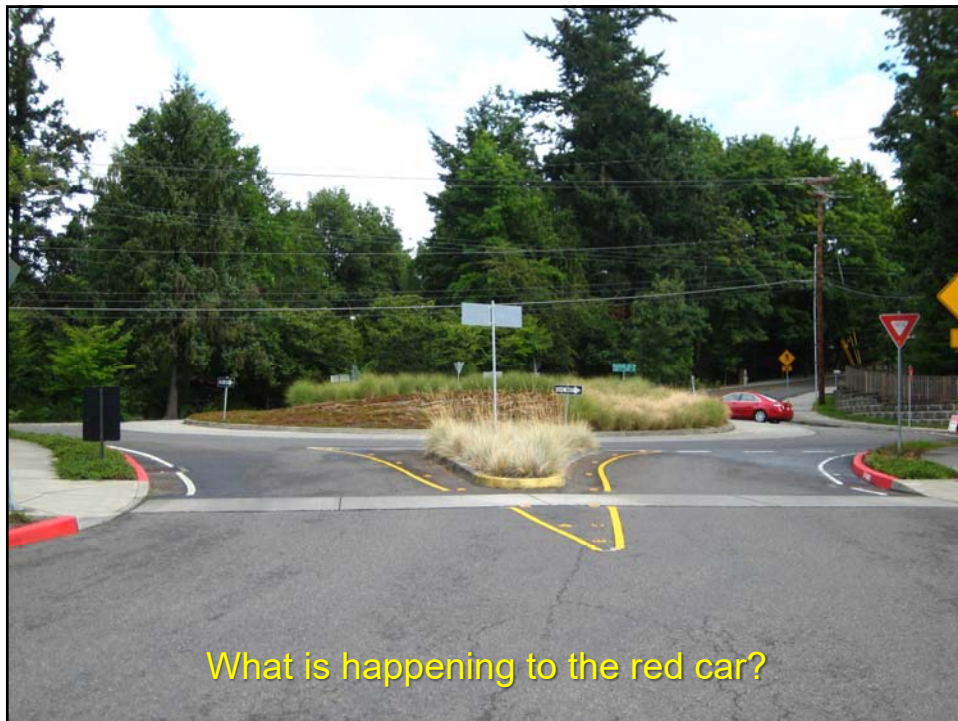
What is happening to the red car?

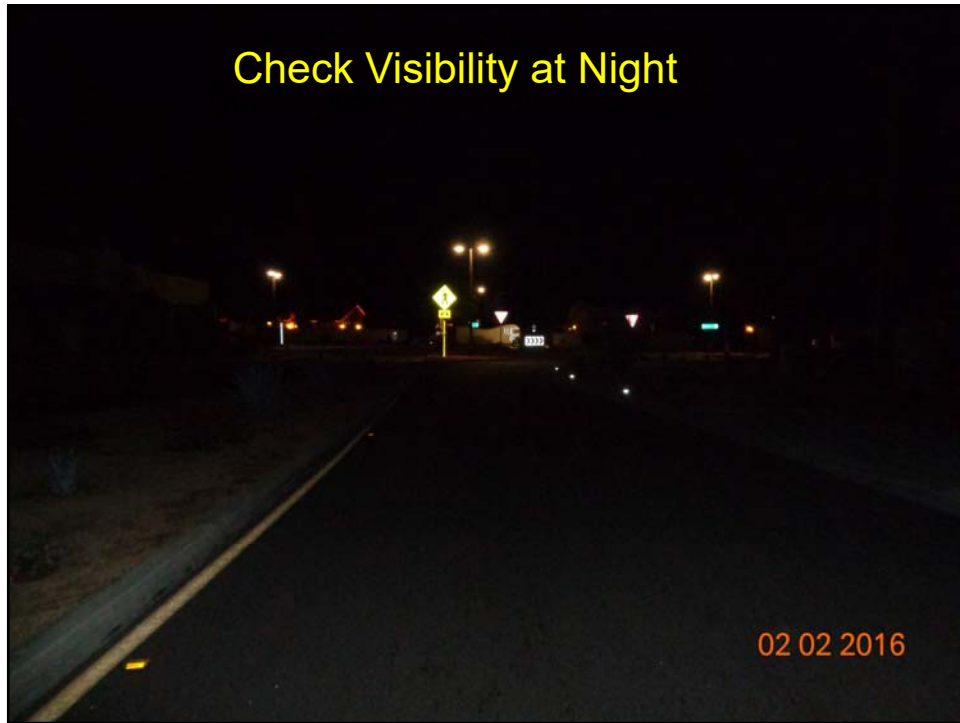
Check Visibility at Night

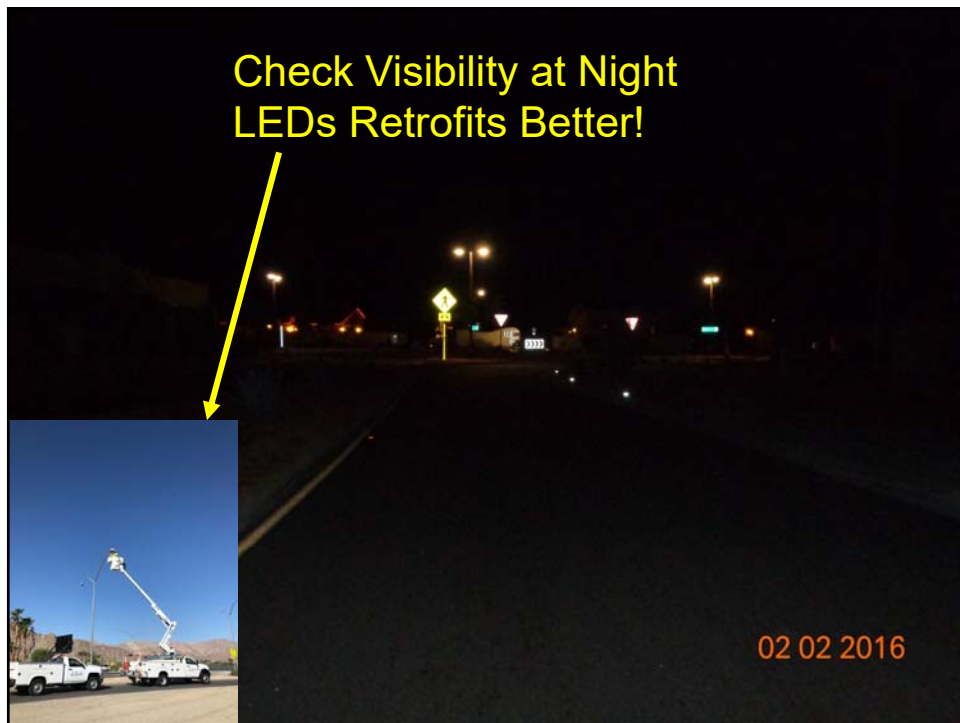
Check Visibility at Night LEDs Retrofits Better!
